**CALSPAN ON-SITE AMBULANCE CRASH INVESTIGATION**

**SCI CASE NO.: CA12030**

**VEHICLE: 2001 FORD ECONOLINE 350 / MEDTEC TYPE III AMBULANCE**

**CRASH DATE: JUNE 2012**

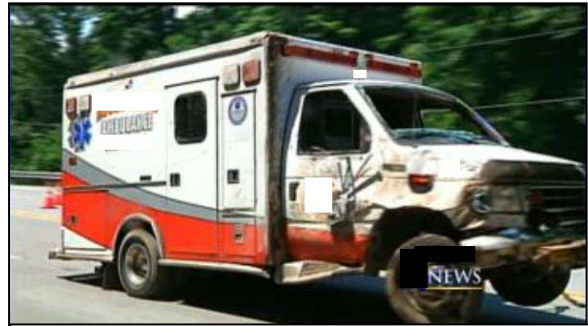
**Figure 1:** Damaged Ford ambulance being towed from the scene (*Image obtained from a local news source*).

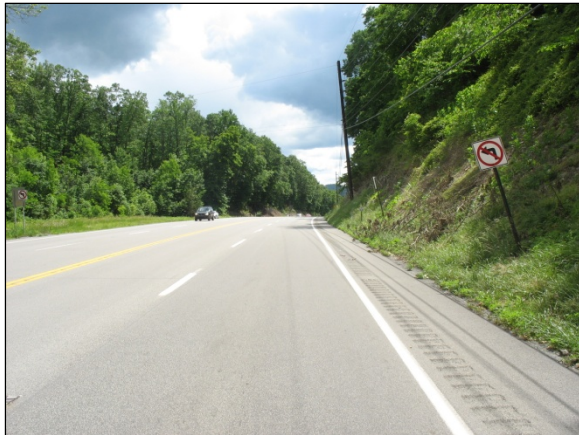
**Figure 2:** Southbound trajectory view of the ambulance's pre-crash travel path.

For the Ford ambulance's pre-crash travel trajectory, the roadway ascended a hillside with a slight right curvature (**Figure 2**). The slope of the grade was +3.5%, with a roadway superelevation of +2.8%. To the east, the roadway edge transitioned to a shallow ditch with roadside swale that ascended sharply up the hillside. The roadway began to achieve a natural crest, with the grade decreasing to +1%. Superelevation of the roadway within this vicinity was +3.1%. East of the road edge was a 1.5 m (5 ft) diamond-shaped sign for northbound traffic. This large sign was affixed to a pair of 5x5 cm (2x2 in) non-breakaway steel posts. Immediately east and south of this sign, the roadside swale transitioned sharply into a steep embankment with +75.7% grade that ascended toward the hilltop (**Figure 3**). This embankment paralleled the roadway south of the sign. A second 0.3 m (1 ft) square highway sign was located at the edge of the roadway, 13.9 m (45.5 ft) south of the large sign. A Crash Diagram is included on page 17 of this technical report.

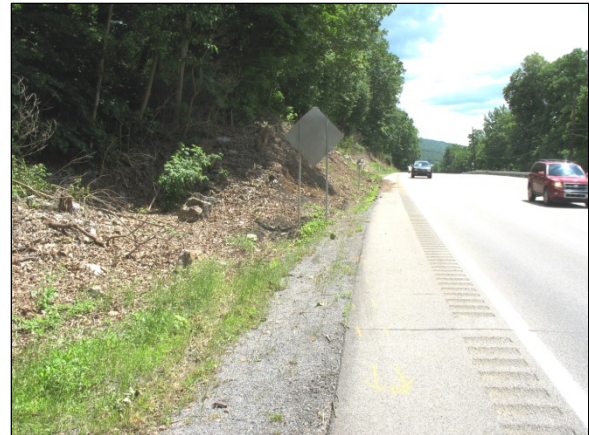
**Figure 3:** Roadway signage and hillside embankment on east roadside.

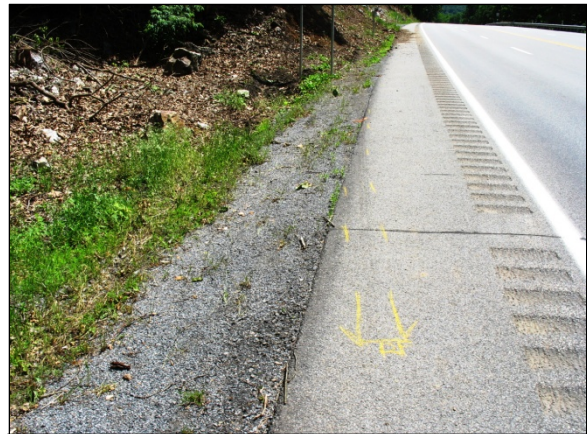
Maintaining its errant trajectory in a tracking attitude, the ambulance's tires crossed over the rumble strips of the east shoulder as its frontal plane departed the roadway edge. The resulting vibration of the tires and wheels of the Ford on the rumble strips suddenly awakened the driver. After a brief delay in response as she identified the impending departure into the east roadside swale, the driver provided an abrupt braking and right steering input. Longitudinal skidding tire marks on the edge of the asphalt roadway and through the roadside swale evidenced the ambulance's trajectory (**Figure 4**).

**Figure 4:** Skid marks within the shoulder and roadside swale evidenced the Ford's errant trajectory.

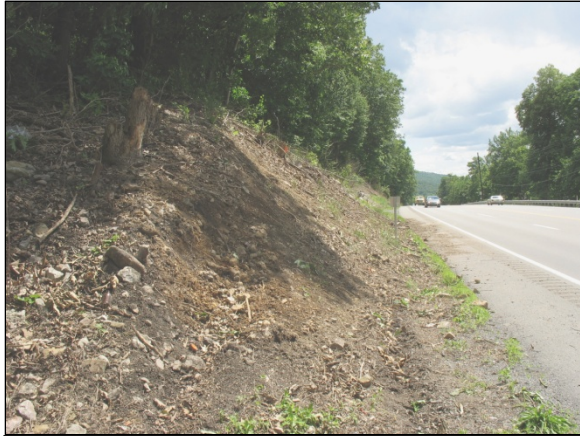
**Figure 5:** Displaced soil, rock, and vegetation that evidenced the Ford's Event 3 impact and trajectory.

As the Ford progressed along the roadside, its frontal and undercarriage planes impacted the ground surface of the steep roadside embankment (Event 3) and it began to traverse up the steep incline. This impact was evidenced by the displacement of rock, soil, and vegetation (**Figure 5**). As the ambulance mounted the embankment and began to traverse its steep cross-slope, the vehicle initiated a counterclockwise (CCW) yaw. The Ford's right plane then impacted and overrode a small roadway sign (Event 4), located 38 m (124.7 ft) south of its point of initial roadside departure.

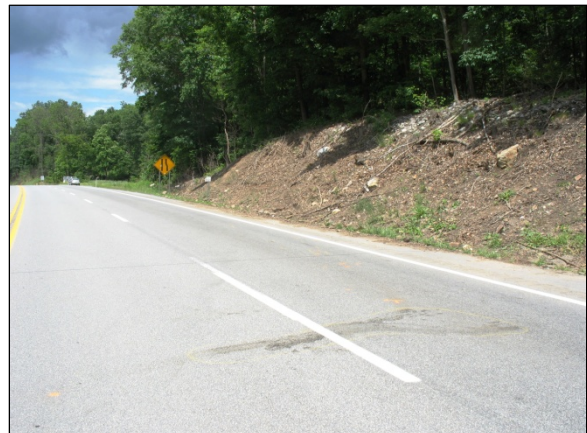
**Figure 6:** Look-back view of the ambulance's fall-over location and sliding trajectory.

on the roadway evidenced the ambulance's final rest position, which was located 65.5 m (215 ft) south of its initial roadside departure point. At rest, the vehicle was positioned on its right plane within the northbound lanes, facing southeast at an angle rotated 25 degrees CCW from its original heading angle. A look-back view of the ambulance's fall-over location and trajectory to final rest is depicted in **Figure 6**.

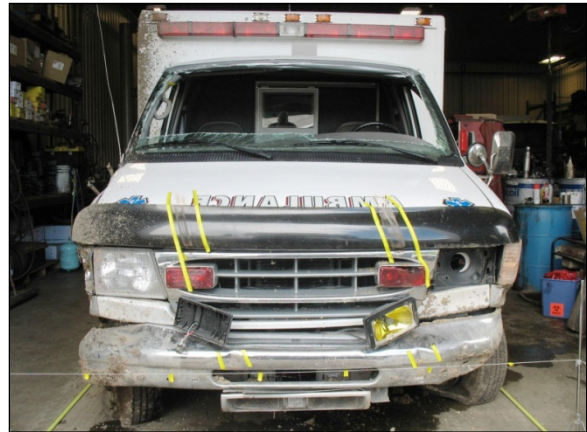
**Figure 9:** Overhead view of the severe frontal plane damage to the Ford/Medix Type II ambulance.

Direct and induced contact damage associated with the embankment (Event 3) impact spanned the Ford's entire 174 cm (68.5 in) frontal width. The damage pattern consisted of longitudinal and vertical bumper deformation, with the fracture of the polymer shroud encasing an emergency siren speaker mounted beneath the bumper. There was also noticeable induced deflection of surrounding frontal components. A residual crush profile documented at bumper level produced the following measurements: C1 = 9 cm (3.5 in), C2 = 1 cm (0.4 in), C3 – C5 = 0 cm (0 in), and C6 = 1 cm (0.4 in). Maximum crush for the Event 3 damage pattern was located at C1. The CDC assigned to the ambulance was 00FDLW1. No WinSMASH calculations were performed because the non-horizontal nature of the impact forces did not fall within the scope of the model's parameters. The exact location of direct and induced damage on the right plane of the ambulance related to the Event 4 impact with the small non-breakaway sign could not be determined due to the overlapping damage associated with the Event 5 rollover. Accordingly, the CDC assigned to the ambulance for the Event 4 damage was 99R99999. No WinSMASH calculations could be performed due to the unknown severity of the damage and lack of applicable measurements.

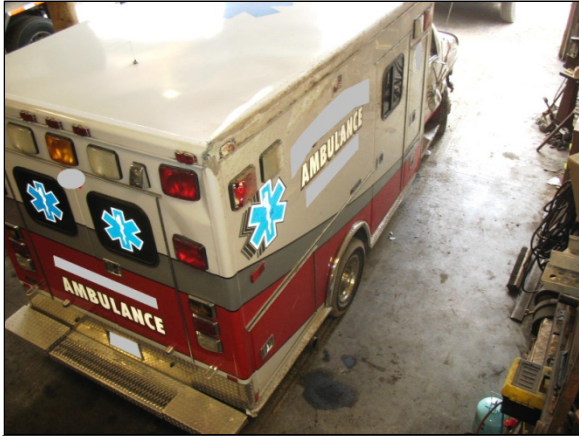
**Figure 10:** Overhead view of the right plane damage and right roof side rail buckling sustained by the Ford/Medtec Type III ambulance.

Right plane damage associated with the rollover sequence (Event 5) consisted of minor body surface deformation and abrasions (**Figure 10**). This included an area of buckling along the right roof side rail of the patient compartment module, predominant at the rear aspect. Multiple lens covers of side warning and marker lights were fractured or disintegrated. The right side mirror had separated from three of its four mounting locations and dangled precariously from the right front door. Maximum lateral deformation to the Ford's cab was present on the front fender, above the right front axle, and measured 7 cm (2.8 in)

in magnitude. The maximum deformation sustained by the patient compartment was 5 cm (2 in) lateral deformation at the upper rear corner of the right plane, along the right roof side rail. No vertical crush was associated with the minor severity, one quarter-turn rollover event. The CDC assigned to the ambulance for the rollover (Event 5) damage pattern was 00RDAO2. Due to the non-horizontal nature of the rollover forces, no WinSMASH calculations could be computed.

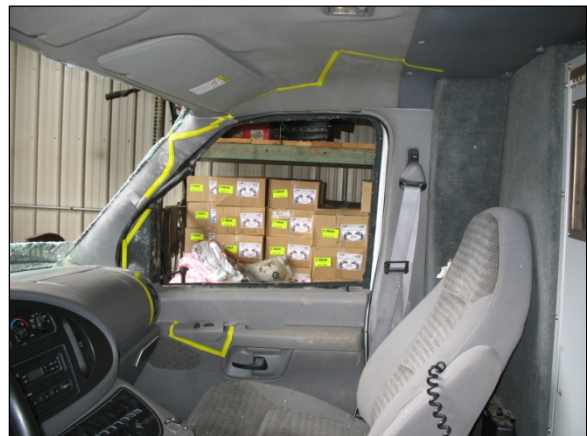
**Figure 11:** Highlighted contact points within the Ford's cab attributable to the unrestrained front right occupant's kinematics.

Occupant contact points within the cab were located on components surrounding the front right occupant, attributable to the unrestrained front right occupant's kinematics. These included scuffs and deformities to the upper right A-pillar, right roof side rail, headliner, right upper instrument panel, forward upper door quadrant, and right upper A-pillar grab handle. There was also blood and body tissue on the right upper A-pillar and the exterior surface of the right front door.

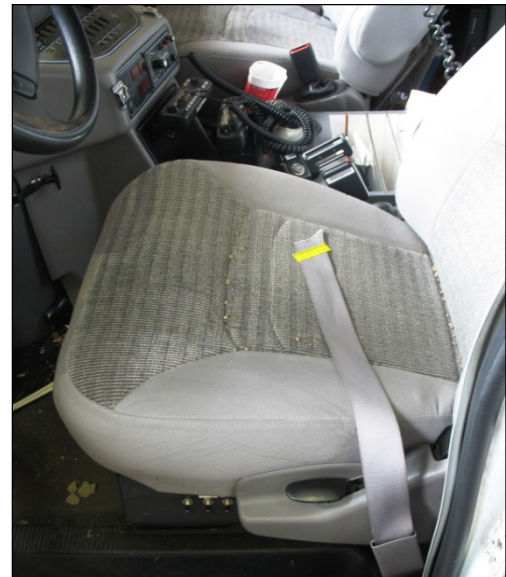
At the time of the SCI inspection, the driver's safety belt webbing was cut 50 cm (19.7 in) above the lower anchor location. The latch plate remained engaged within the buckle, with the cut portion of the webbing having retracted onto the ALR retractor. The D-ring was adjusted fully upward. This evidence confirmed belt usage by the driver at the time of the crash. The front right safety belt system was loosely retracted against the right B-pillar, with the D-ring adjusted to its full-up position. There was no evidence on the front right safety belt system indicative of its use at the time of the crash. Depicted in **Figure 12** is a cut portion of the driver's safety belt system and the latch plate, which was still engaged within the buckle at the time of the SCI inspection.

**Figure 12:** Cut portion of the driver's safety belt webbing and buckled latch plate.

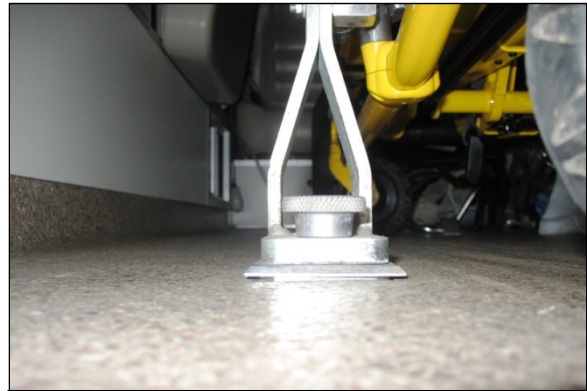
During the rollover crash event, lateral crash forces induced a right lateral trajectory to the stretcher (with respect to the patient compartment's floor). The mass of the stretcher, coupled with the associated lateral crash forces, translated through the locking pin and frame to the locking-clamp mechanism and antler bracket. The stretcher's forward frame and guide wheels loaded the antler bracket, which restricted the lateral movement of the stretcher. This created a negative moment of inertia to the stretcher, which translated lateral forces on the locking clamp. The magnitude of the resultant forces exceeded the load capacity of the anchor bolts and subfloor securing the clamp to the patient compartment's floor, and the clamp deformed right laterally. In such a manner, the stretcher moved laterally 8 cm (3.1 in), but did not disengage from the locking clamp. This movement is depicted in **Figures 14 and 15**. The stretcher itself did not sustain any apparent damage during the crash sequence. All adjustments and mechanical components functioned within their intended limits.

**Figure 14:** Orientation of the Ford's locking clamp mechanism when moved to its original position.

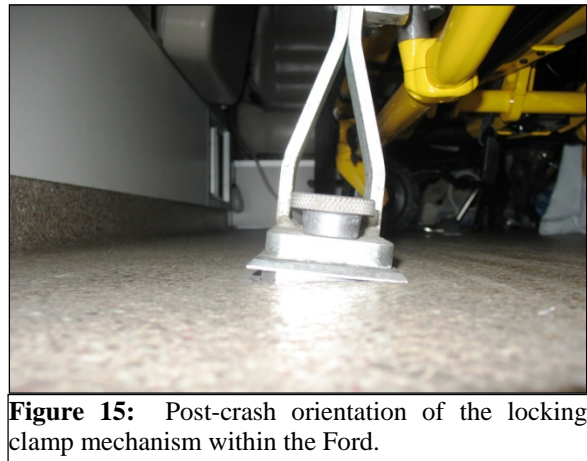
**Figure 15:** Post-crash orientation of the locking clamp mechanism within the Ford.
